Troubleshooting laboratory aspects of MLVA

Eija Trees, Ph.D., D.V.M.
PulseNet Methods Development and
Reference Unit
Enteric Diseases Laboratory Branch
CDC, Atlanta, GA

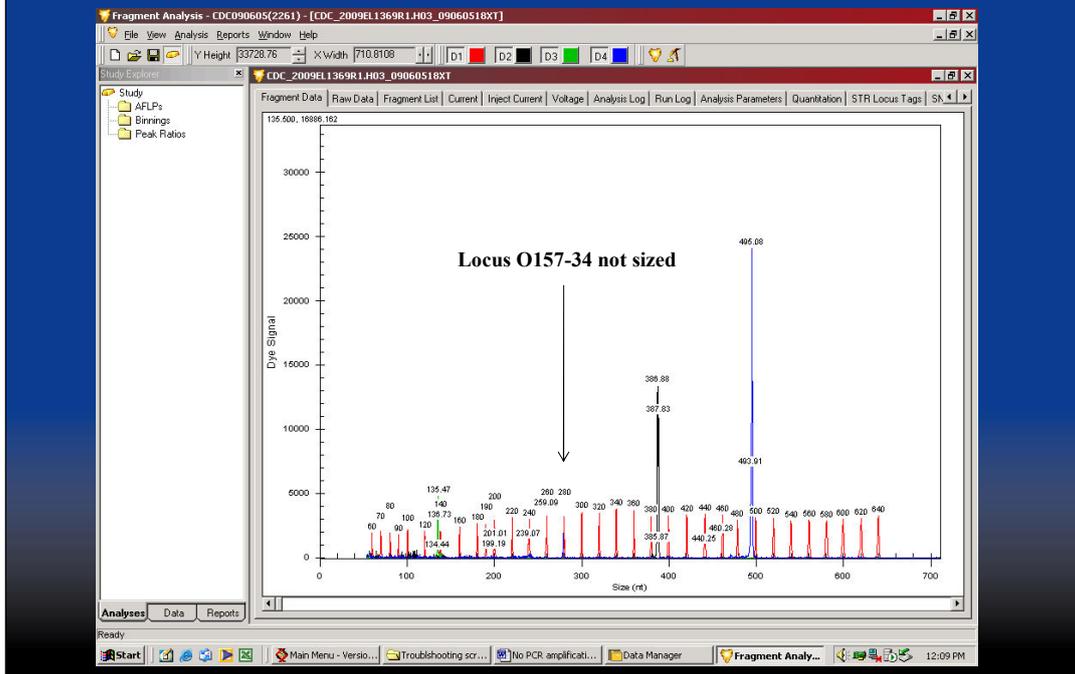
Weak amplification of one locus due to degraded primers - CEQ

The primer working stocks degrade due to freeze-thaw cycles. New working stocks should be prepared from the concentrated stocks when a significant drop in the fluorescence intensity is observed. The concentrated stocks should be stored in small aliquots at -70°C . The concentrated stocks typically store for 2 to 3 years.

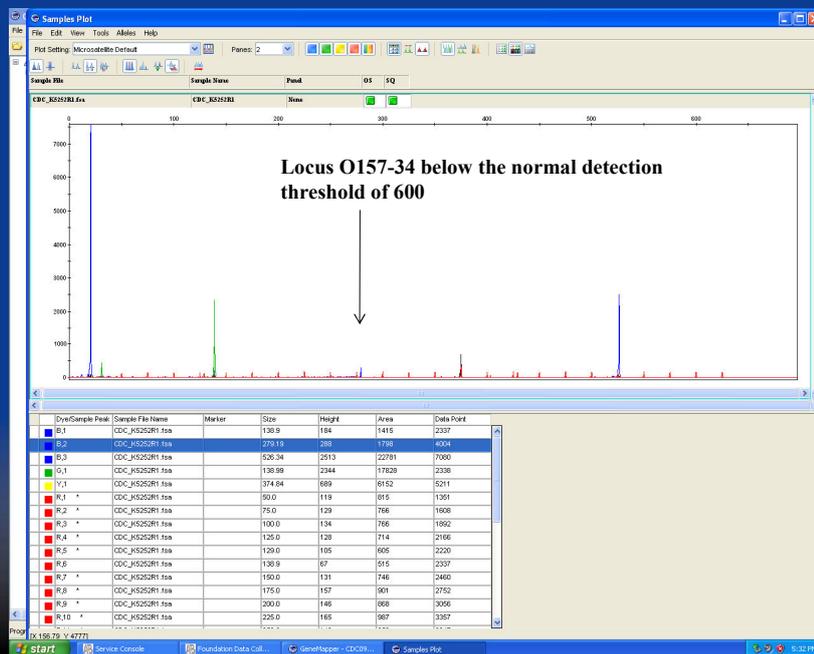
Weak amplification of one locus due to pipetting error - ABI

Since the pipetting volumes are very small, extra attention should be paid to careful pipetting techniques. Pipettes should also be regularly (every 6 to 12 months) calibrated.

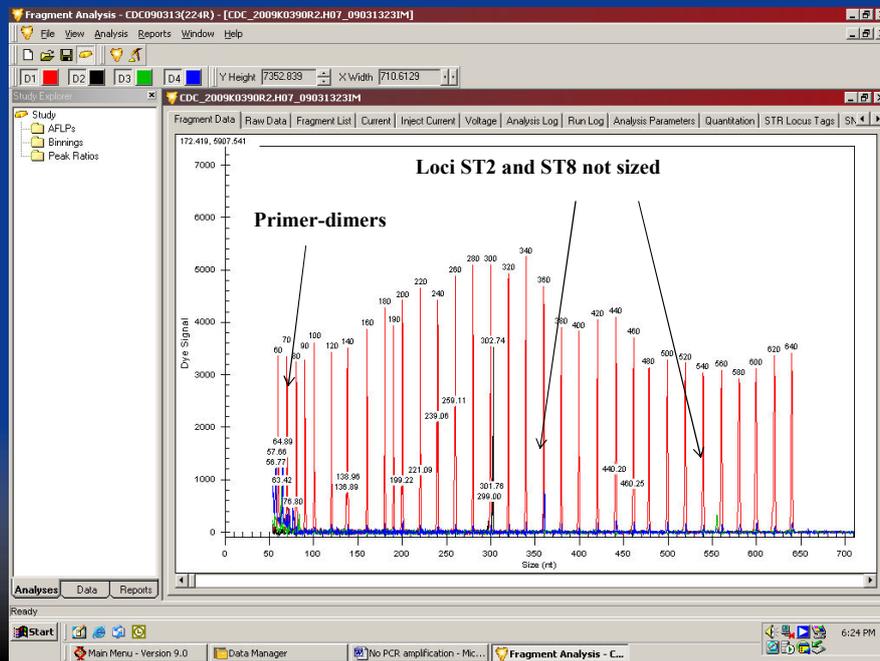
Weak PCR amplification of all loci due to a thermocycler problem - CEQ

If the thermocycler is malfunctioning (for example not reaching the correct temperatures), all targets typically amplify weakly, and a pronounced primer-dimer peak is observed. In some thermocyclers PCR tubes work better than PCR plates due to more efficient temperature distribution.

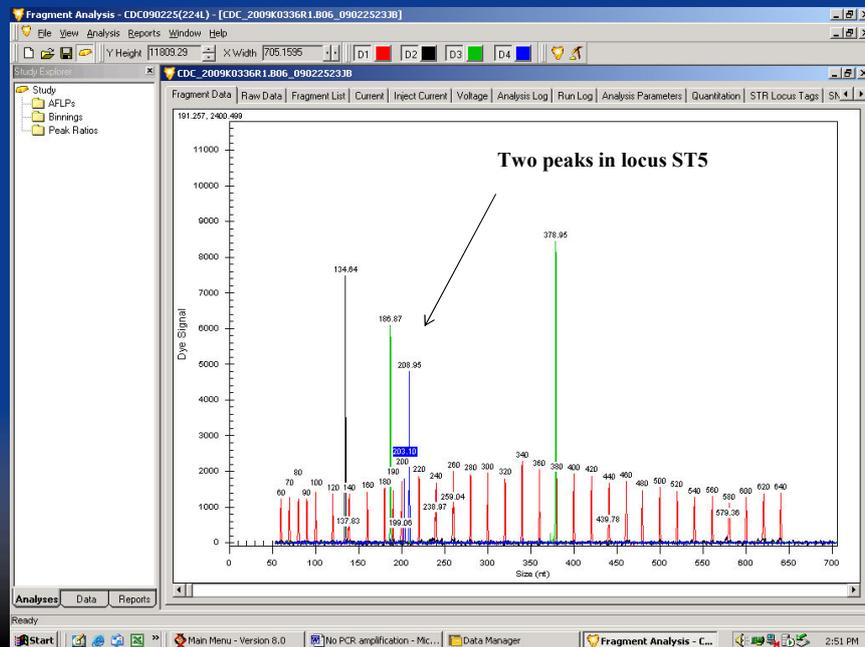
Two peaks in the same locus – contamination or two alleles?

Cross contamination of the fragment analysis reaction or the DNA template may result in multiple peaks being observed in a single locus. In this case, the PCR should always be repeated with a fresh DNA template. In rare cases, an isolate may possess two copies of the same locus in its genome.

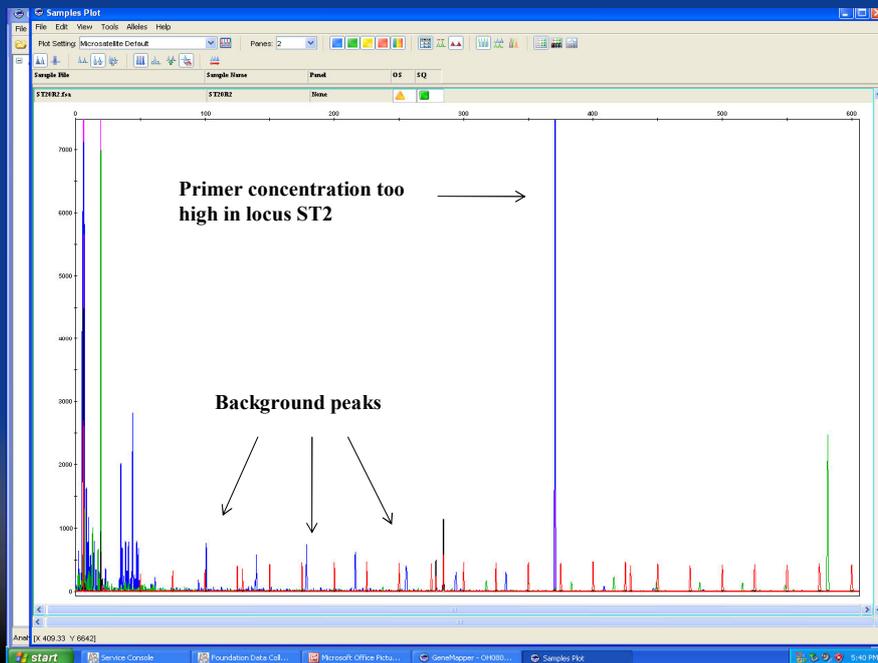
Too high primer concentration causing background - ABI

Too high primer concentration may be caused by a working stock that was prepared wrong or if a new primer stock was introduced to the mix. When primer stocks age, the fluorescence intensity gradually drops necessitating increases in primer concentrations in the mastermix. When a new stock is introduced in the mastermix it is often necessary to adjust the concentrations downwards in order to optimize the fluorescence intensity.

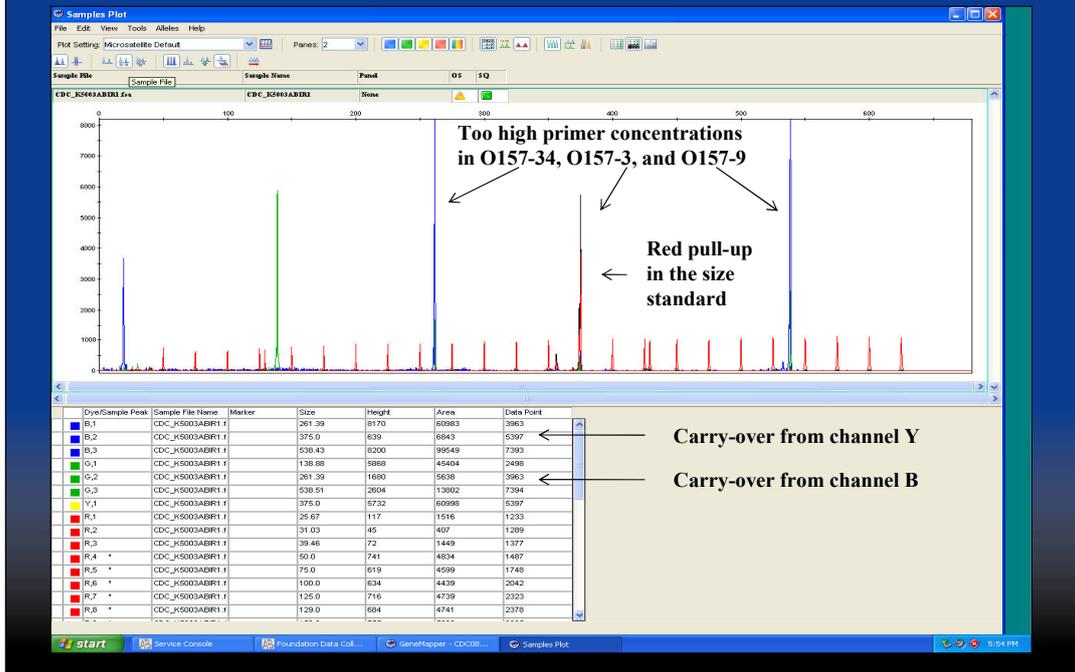
Too high primer concentrations causing fluorescence carry-over - ABI

Too high primer concentrations very often cause fluorescence overflow between channels which is manifested as non-specific carry-over peaks. This problem is particularly pronounced in the Applied Biosystems sequencers. It is therefore important to have the primer concentrations well optimized since the carry-over peaks can interfere with the data analysis. A too high primer concentration can also cause red pull-up in the size standard which may interfere with sizing if the software labels the pull-up peak instead of the actual size standard peak.

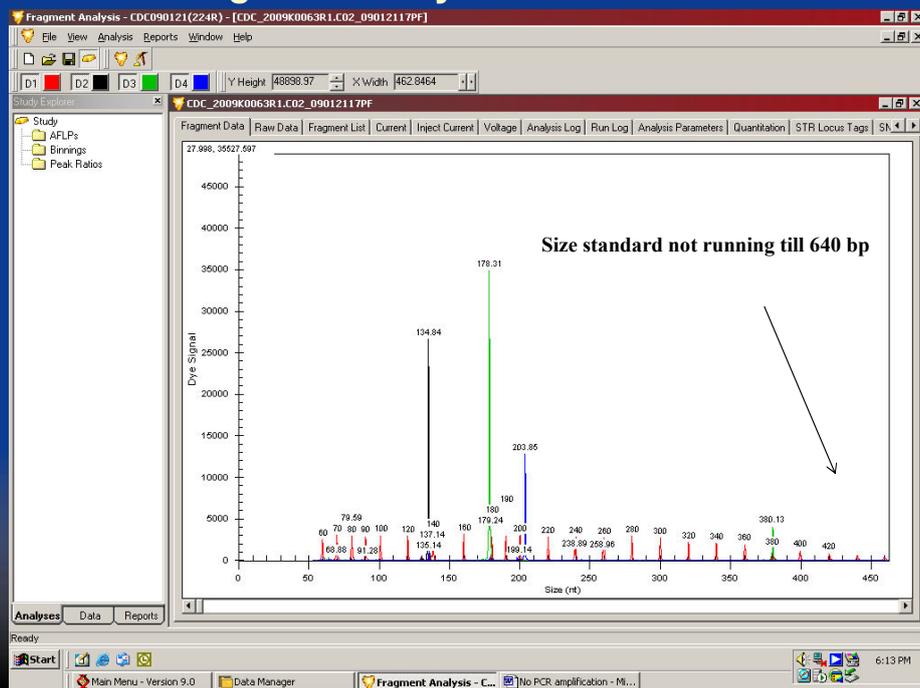
Fragment analysis failure - CEQ

An example of a fragment analysis failure on the Beckman Coulter CEQ. Fragment analysis failures can be caused by expired or degraded size standard or sample loading solution or by a capillary array that is too old (>45-50 days at room temperature) or has too many (>100) runs on it. If reagent and array related issues can be ruled out, an increased failure rate can often be attributed to instrument related issues, and may require a service call.

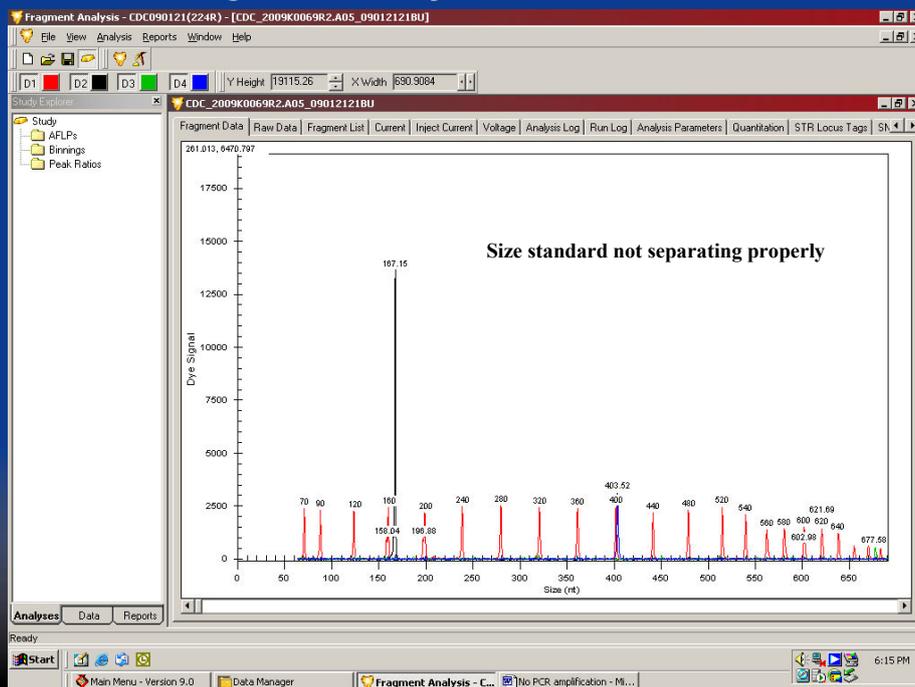
Fragment analysis failure - CEQ

Another example of a fragment analysis failure on the Beckman Coulter CEQ.

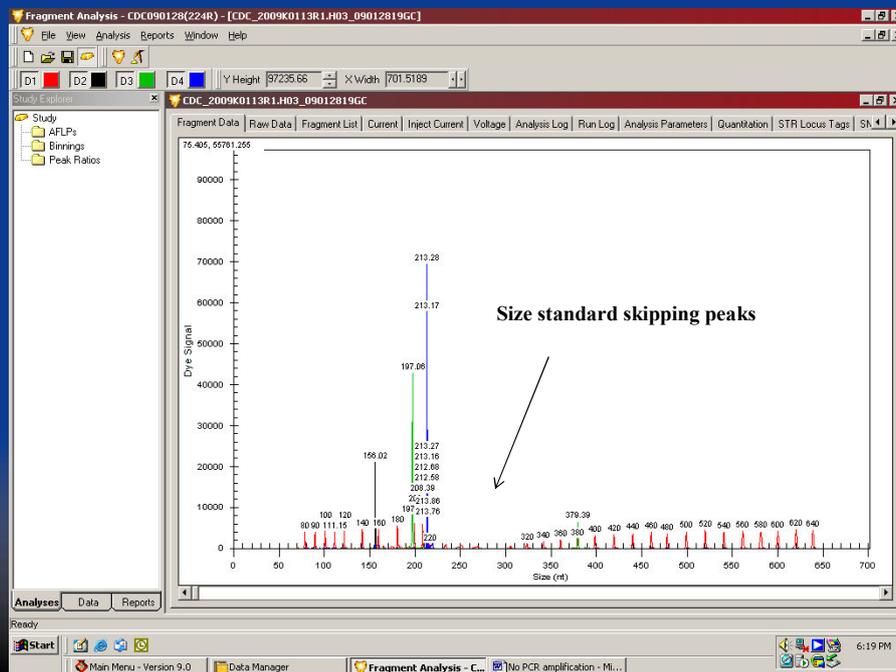
Fragment analysis failure - CEQ

Another example of a fragment analysis failure on the Beckman Coulter CEQ.

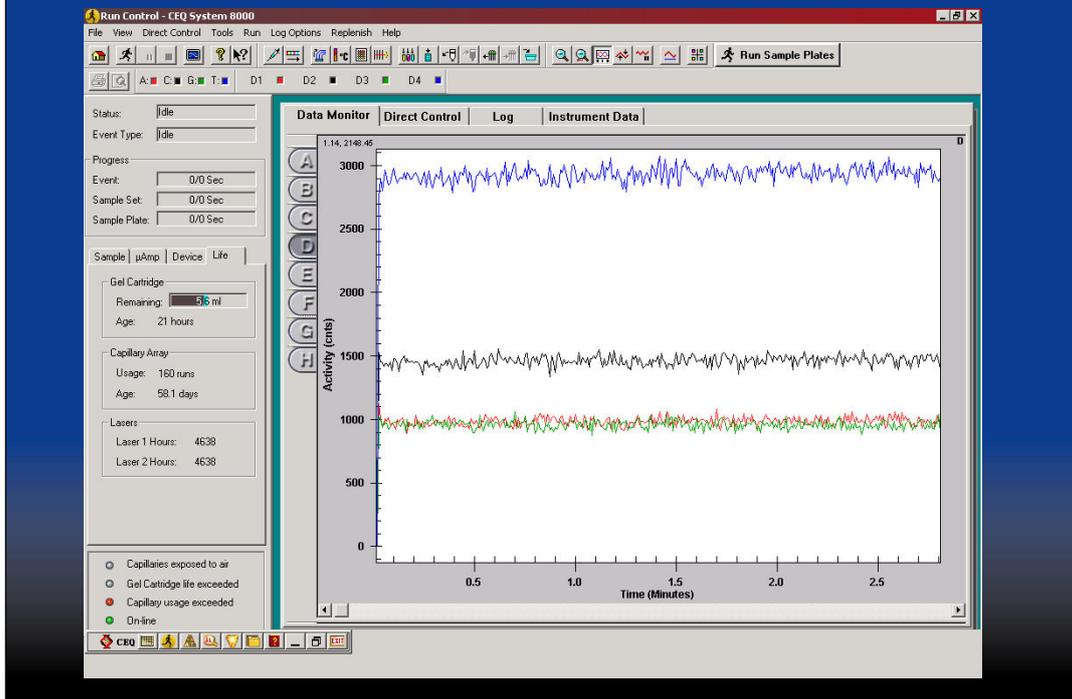
Acceptable background in CEQ < 5,000 units

On the Beckman Coulter CEQ, too high background fluorescence can cause an increased fragment analysis failure rate. Background fluorescence may be high if the array is too old (>45-50 days at room temperature) or has too many runs (> 100) on it. If a new array has high background, cleaning the optical window with a swab moistened with distilled water typically brings down the background.

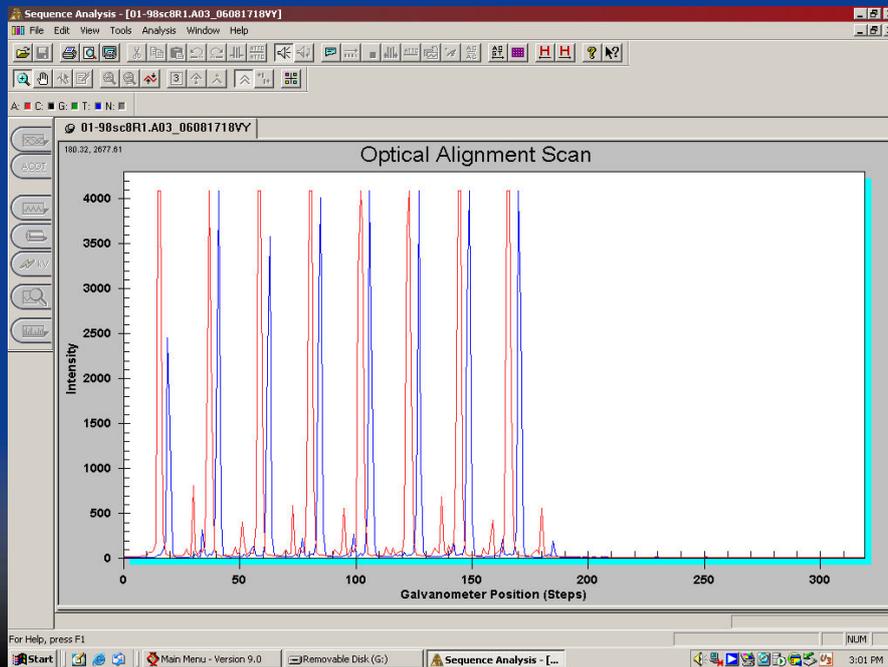
Suboptimal optical alignment - CEQ

An example of a bad optical alignment on the Beckman Coulter CEQ. The peaks start too early and the red and blue peaks are not superimposed.

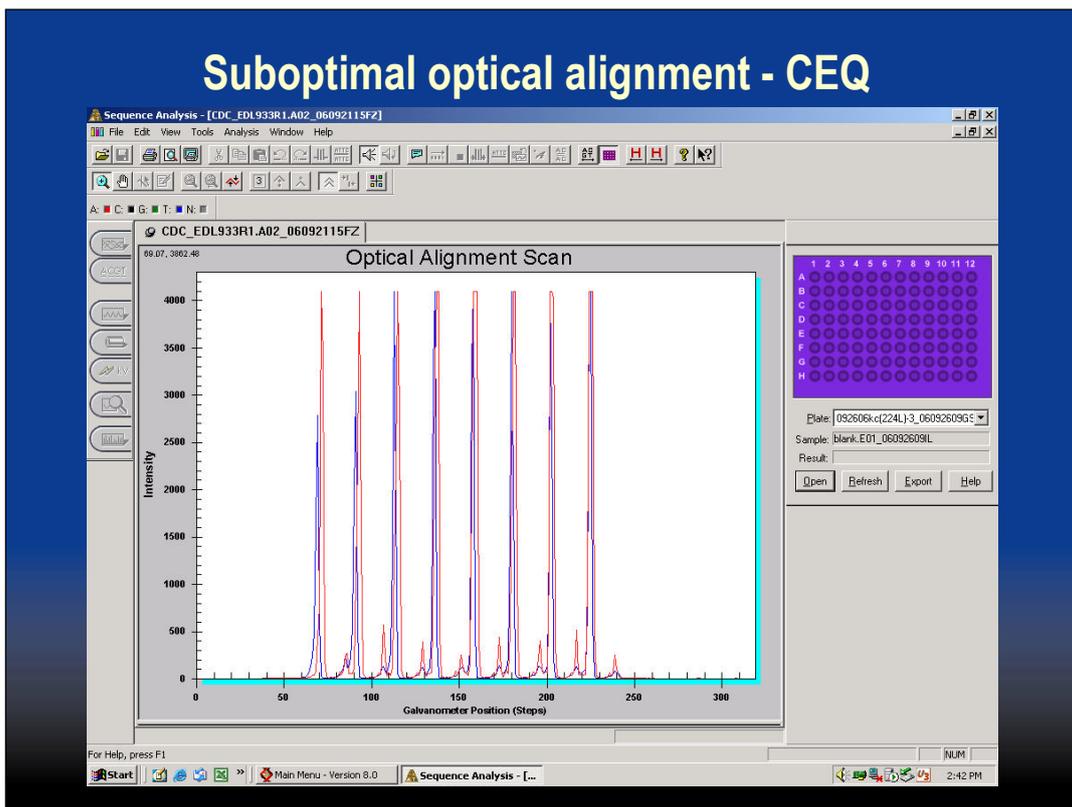
Suboptimal optical alignment - CEQ

An example of a bad optical alignment on the Beckman Coulter CEQ. The peaks start too late.

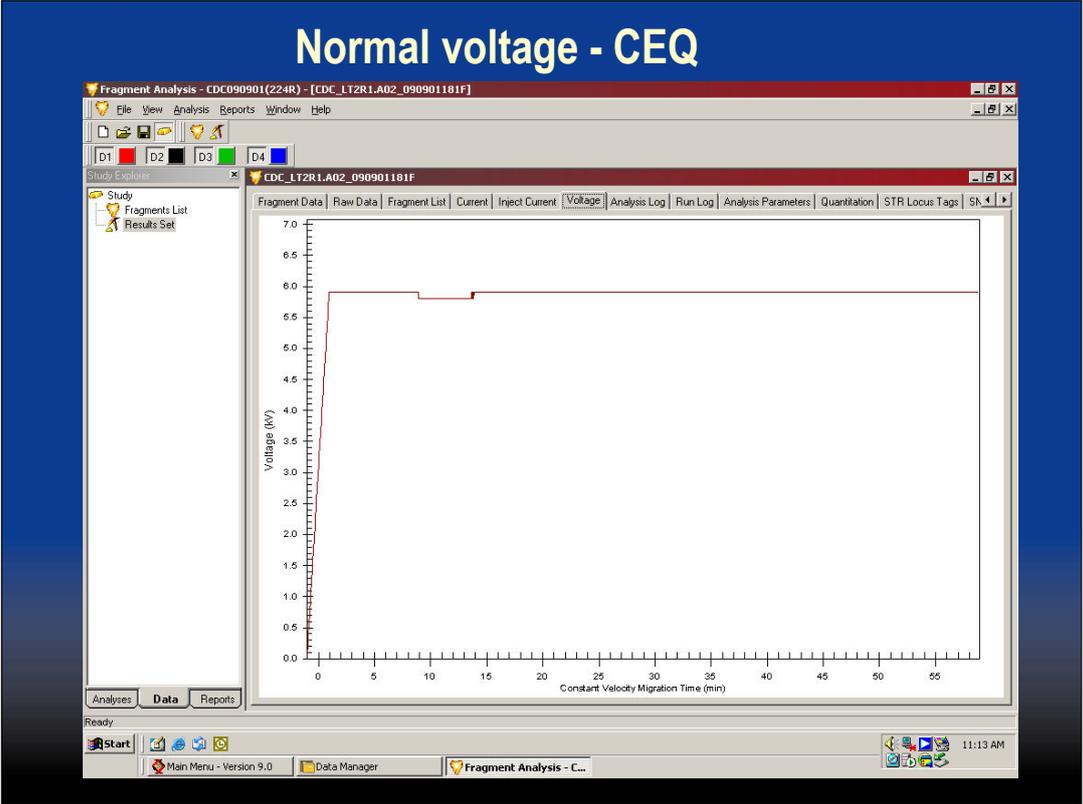
Normal voltage - CEQ

The normal voltage should be at around 6 kV. A voltage crash caused by for example an air bubble in the array can cause the fragment analysis reaction to fail.

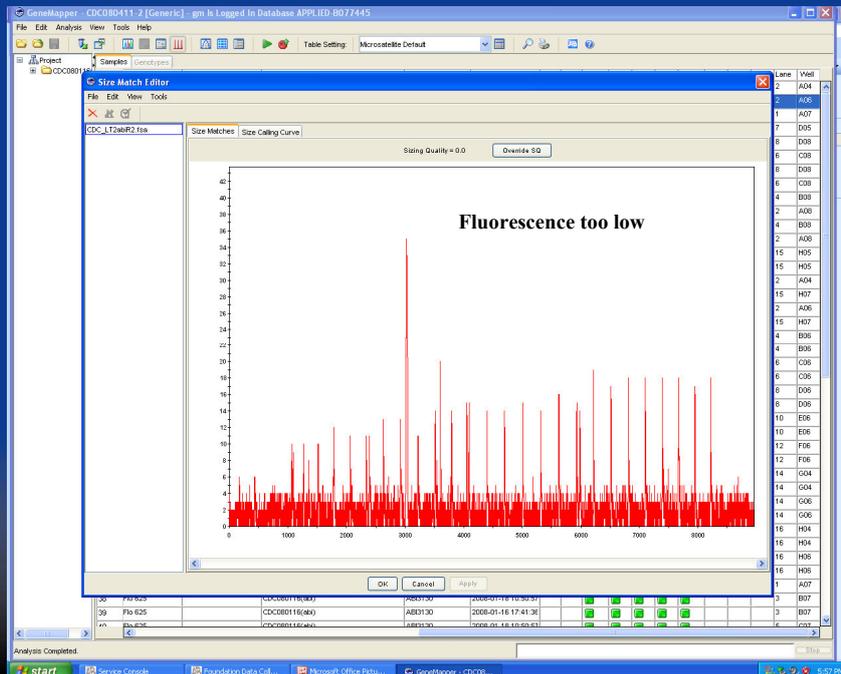
Fragment analysis failure - ABI

An example of a failed fragment analysis reaction on the Applied Biosystems Genetic Analyzer. Just like on the Beckman Coulter CEQ, fragment analysis failures can be caused by expired or degraded size standard or sample loading solution or by a capillary array that has too many runs on it (>80-100). If reagent and array related issues can be ruled out, increased failure rate can often be attributed to instrument related issues, and may require a service call.

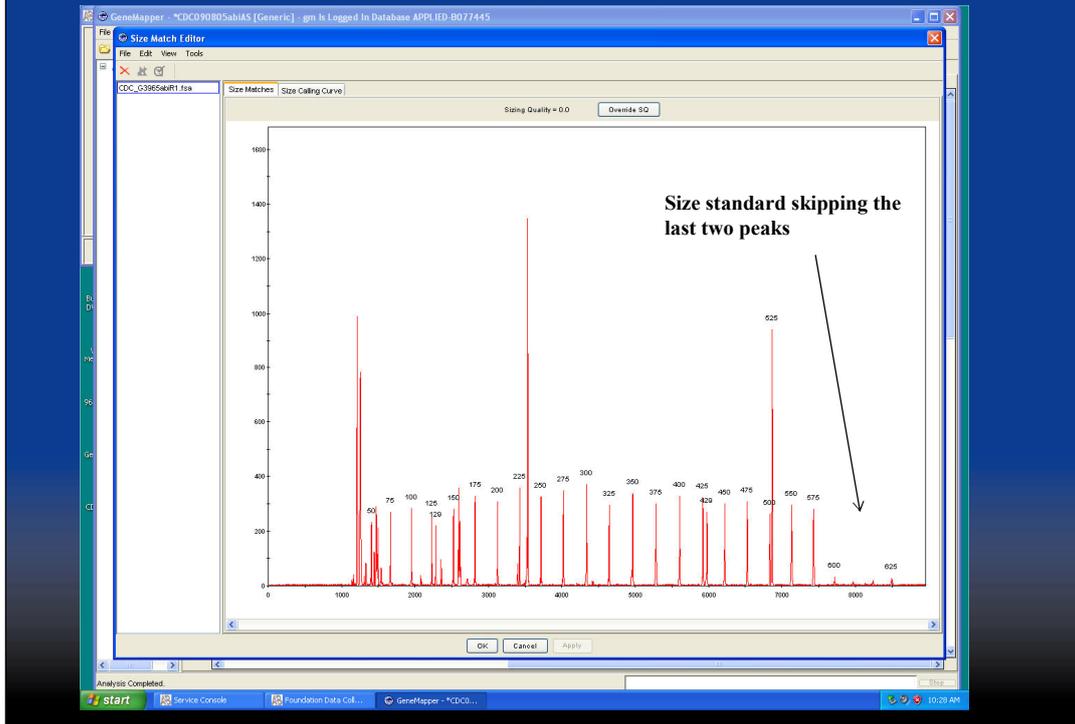
Fragment analysis failure - ABI

Another example of a failed fragment analysis reaction on the Genetic Analyzer

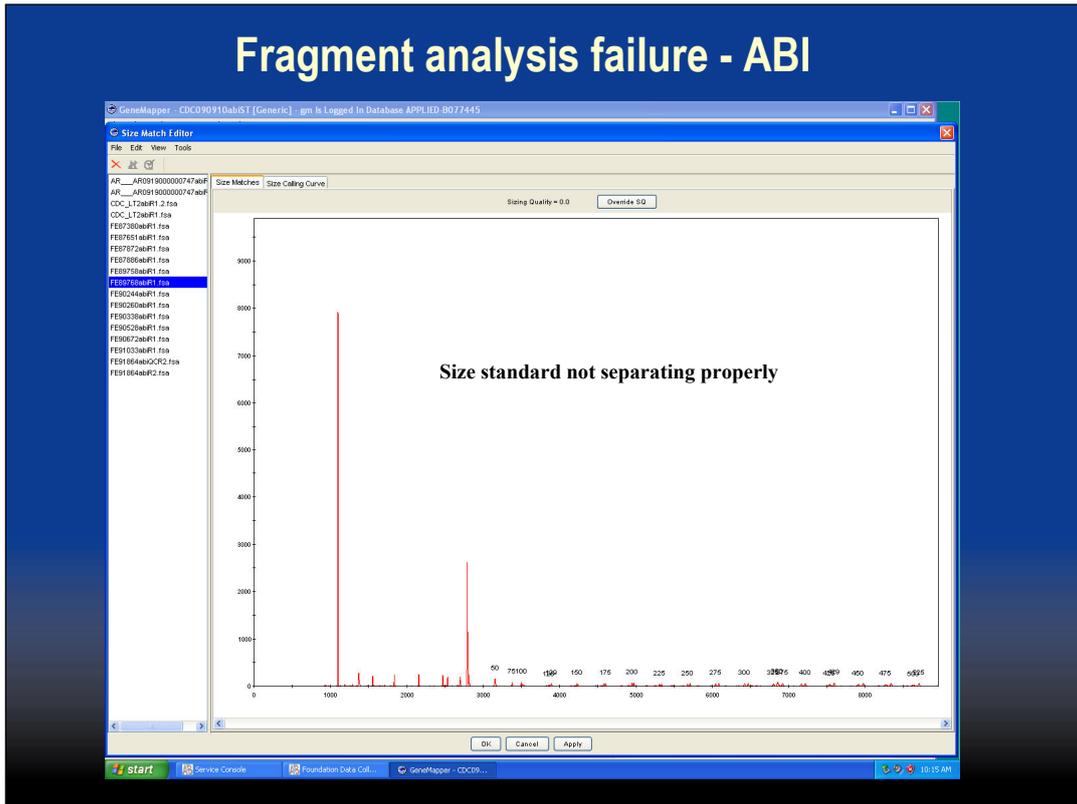
Fragment analysis failure - ABI

Another example of a failed fragment analysis reaction on the Genetic Analyzer

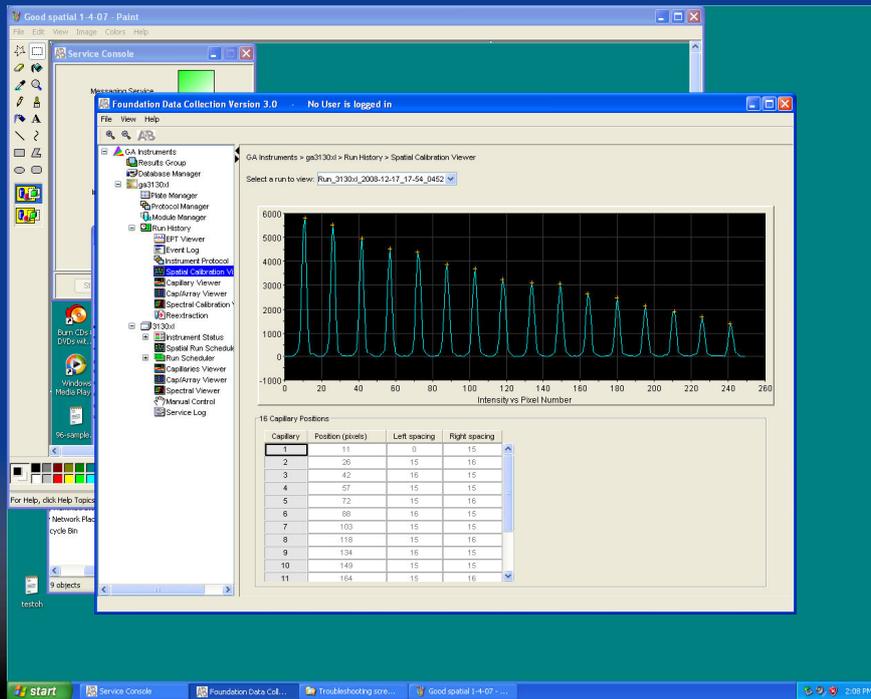
Suboptimal spatial calibration

An example of a suboptimal spatial calibration on the Genetic Analyzer. Suboptimal spatial calibrations require a service call.

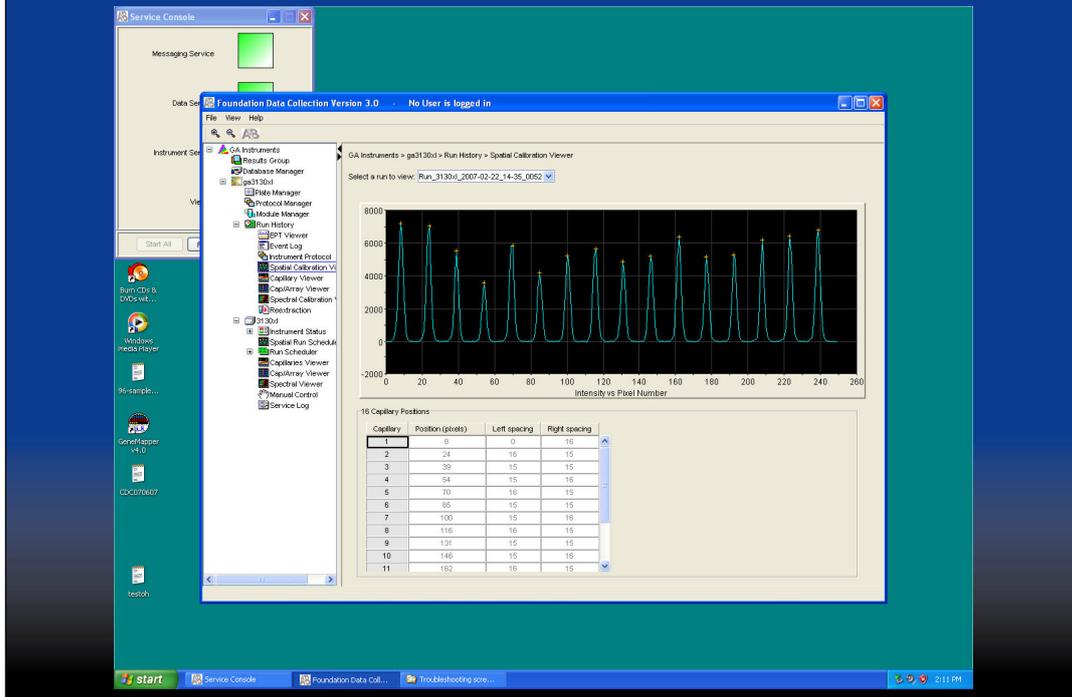
Suboptimal spatial calibration - ABI

Another example of a suboptimal spatial calibration on the Genetic Analyzer.

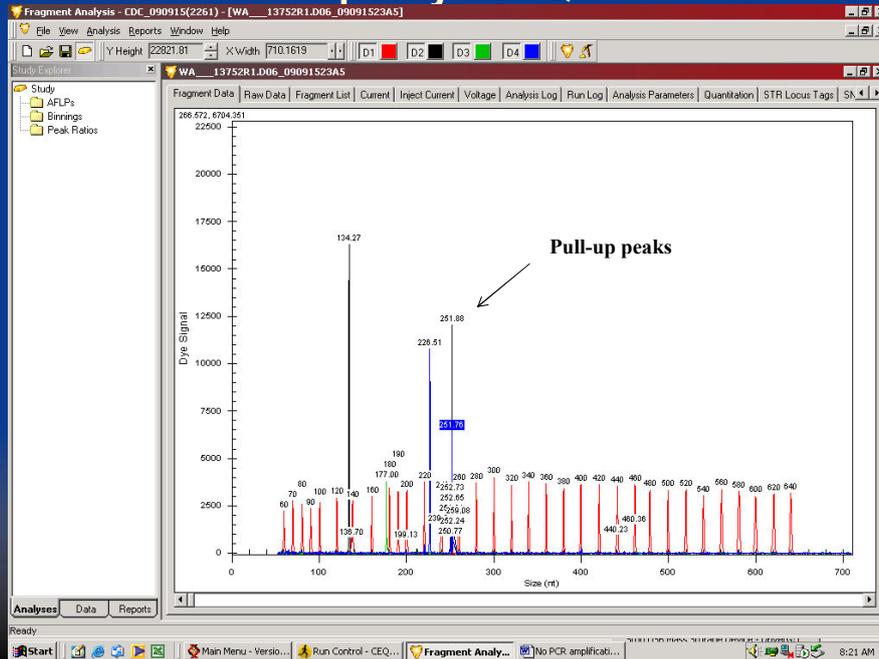
Non-specific pull-up peaks due to suboptimal array quality - CEQ

On the Beckman Coulter CEQ, when the array ages you often start seeing “pull-up peaks” which are manifested as non-specific peaks labeled with two or all three dyes that are exactly the same size. Please note that this phenomenon has nothing to do with PCR. If the same PCR reaction is tested with a newer array, the pull-up peaks would be gone.

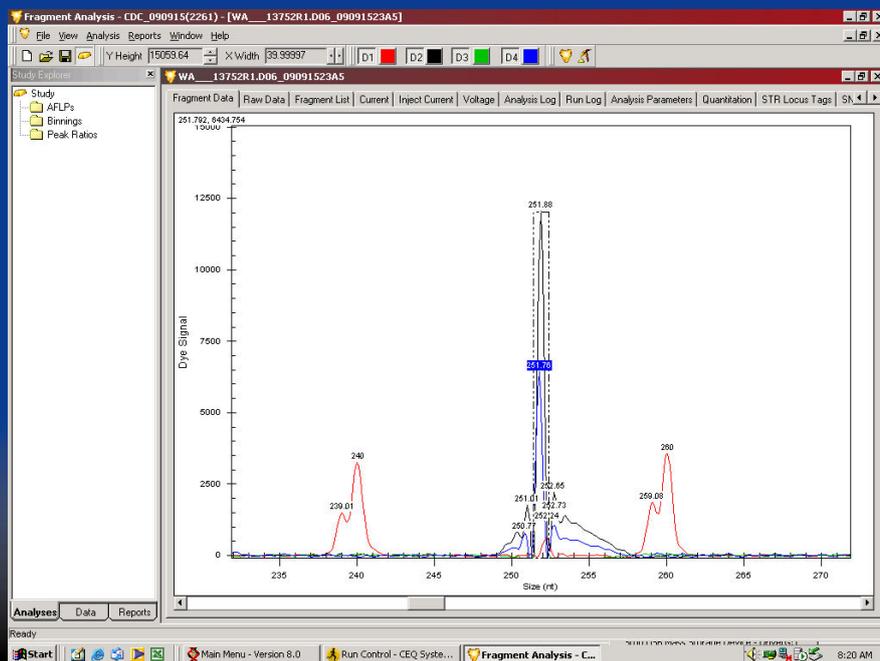
Non-specific pull-up peaks due to suboptimal array quality - CEQ

In this case the pull-up peaks were labeled with D2 (black) and D4 (blue) dyes

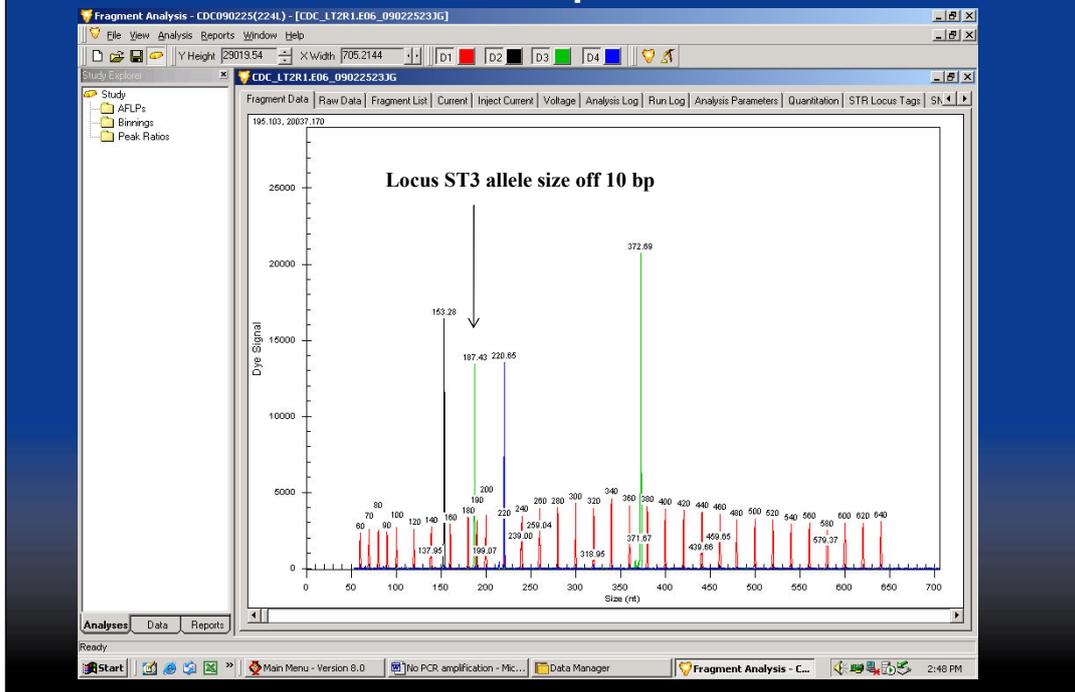
Incorrect sizing of one locus in one entire column – CEQ software problem?

On the Beckman Coulter CEQ, a software malfunction in middle of run can cause some, but usually not all, loci be sized wrong. When this happens, the incorrect sizing usually occurs in entire column and then in the next column sizing appears to be correct. Any fragment analysis reactions in which the observed size does not fit the expected size ranges for known alleles stated in the look-up tables (included in the BioNumerics SOPs) should be repeated. If software malfunctions are frequent, a service call should be placed.

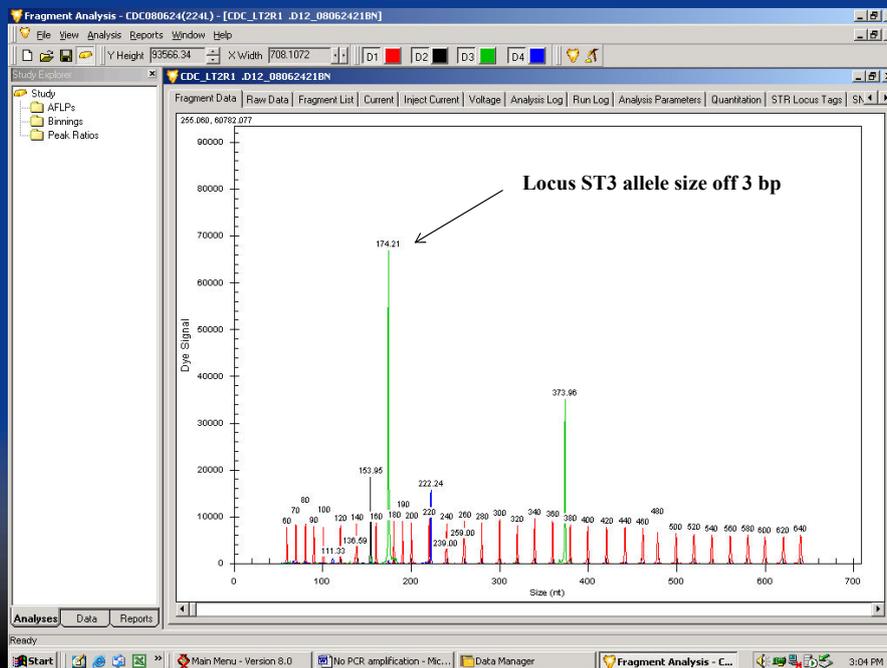
Incorrect sizing of one locus in **whole run** due to expired gel - CEQ

On the Beckman Coulter CEQ, using a gel that has spent more than 72 hours at the room temperature can cause inaccurate sizing.

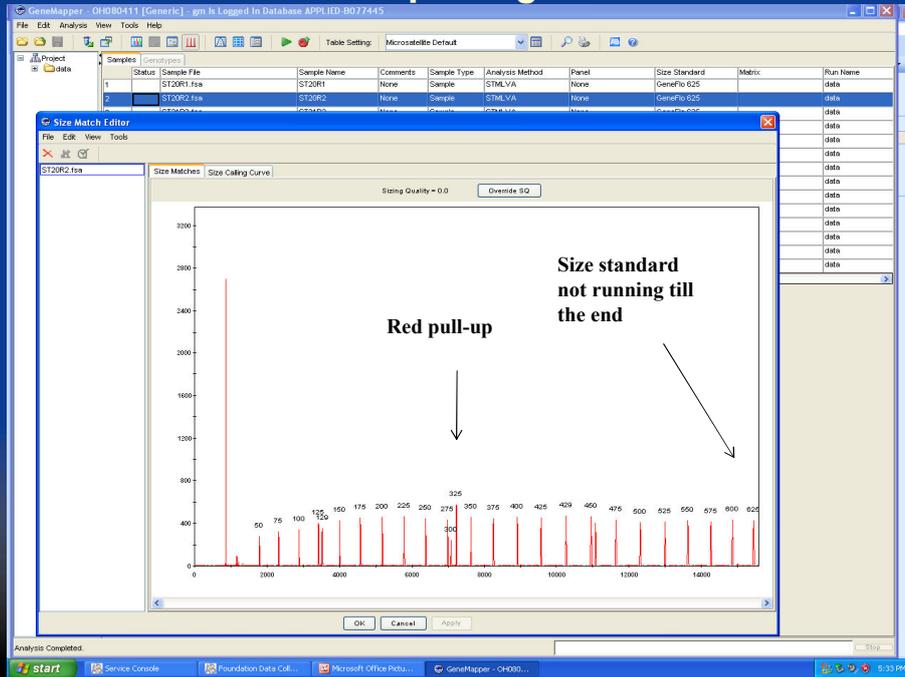
Miscalled size standard peaks due to red pull-up and expired gel - ABI

On the Applied Biosystems Genetic Analyzer, using a gel that has spent more than 8 days at the room temperature can cause the size standard to run short which may result in large fragments being missed. Additionally in this situation, pull-up peaks in the size standard (caused by too a high primer concentration) may be labeled resulting in incorrect sizing of the fragments.

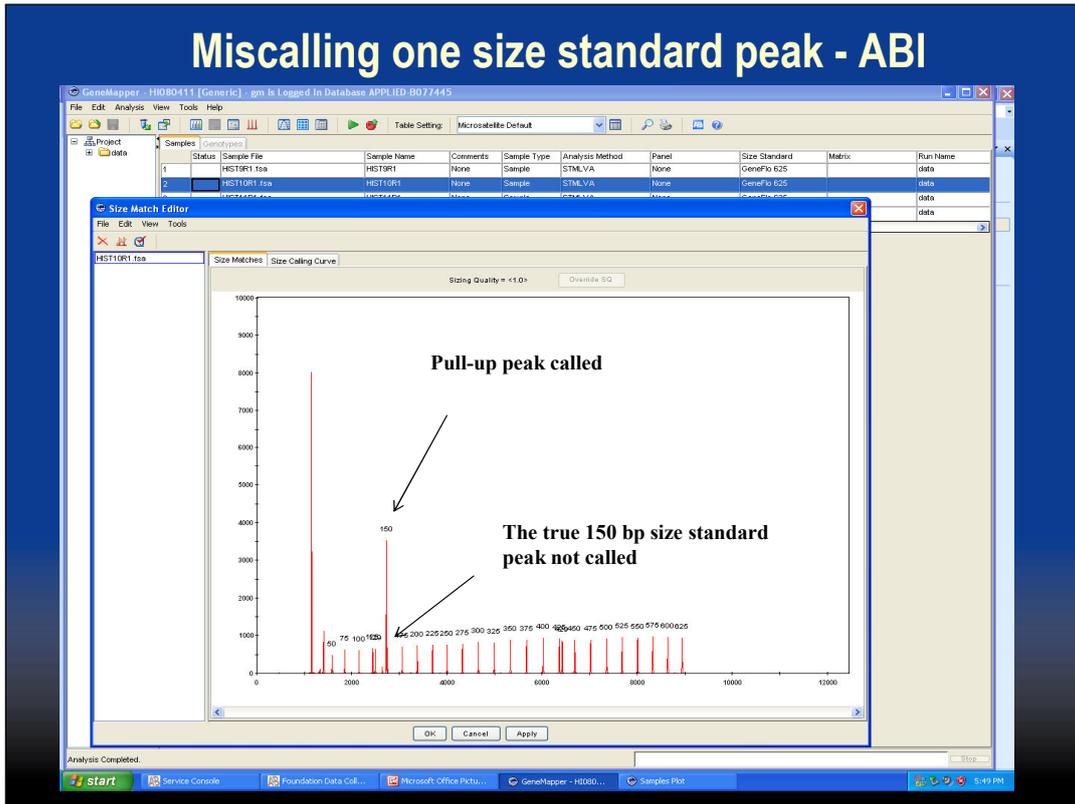
Miscalling one size standard peak - ABI

On the Genetic Analyzer, pull-up peaks in the size standard may sometimes be labeled even when the size standard runs all the way till the end. Errors in the size standard labeling can be manually fixed with the GeneMapper software, and the sample can be re-analyzed without having to rerun the fragment analysis reaction.

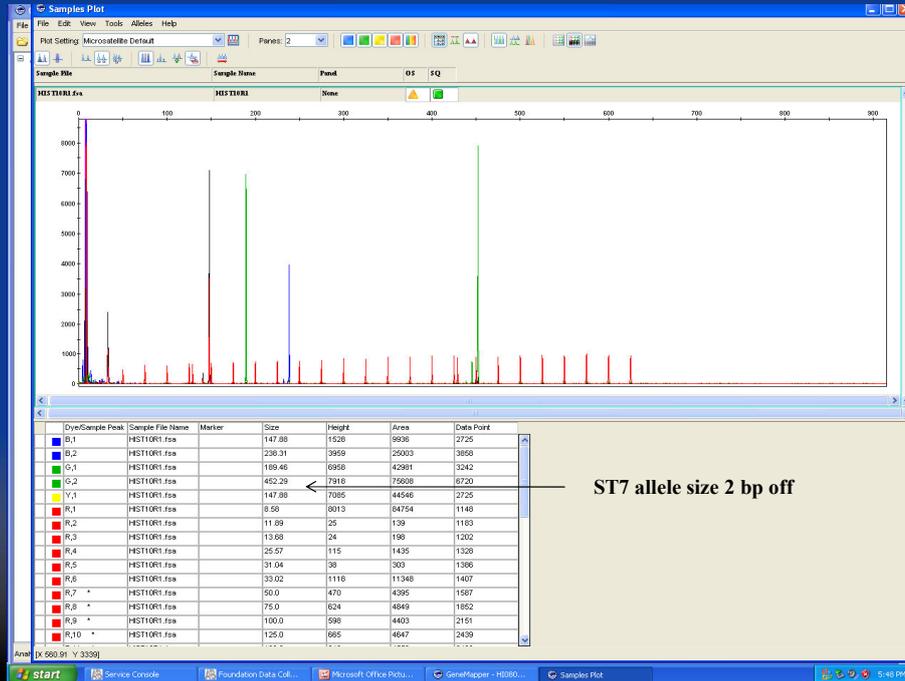
Incorrect sizing due to miscalled size standard peak - ABI

In this case, erroneous labeling of a pull-up peak in the size standard resulted in one fragment being 2 bp outside the accepted size range.
