Troubleshooting laboratory aspects of MLVA

Eija Trees, Ph.D., D.V.M.
PulseNet Methods Development and
Reference Unit
Enteric Diseases Laboratory Branch
CDC, Atlanta, GA

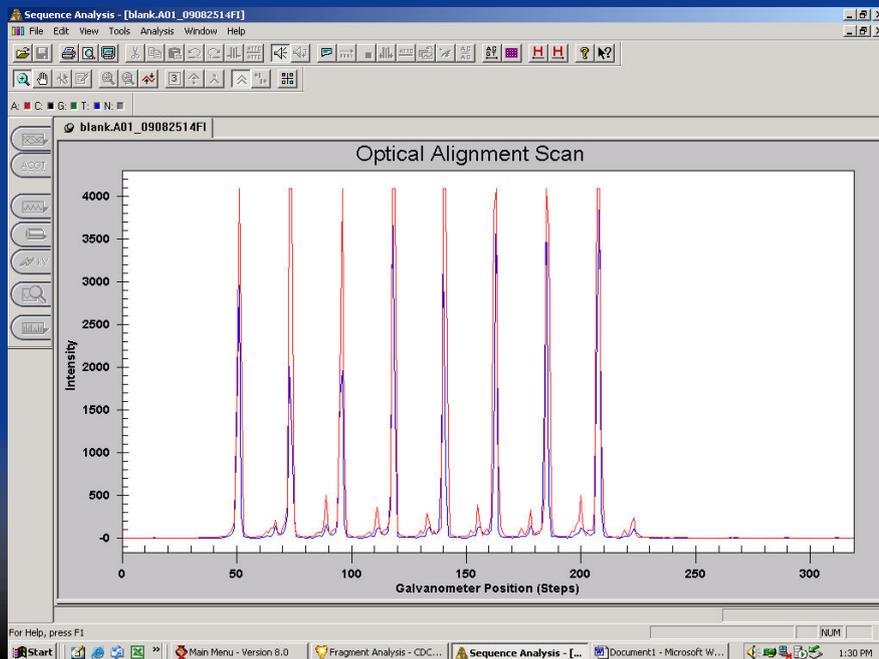
Acceptable optical alignment - CEQ

On the Beckman Coulter CEQ, suboptimal optical alignment can cause an increased fragment analysis failure rate. In an optimal optical alignment, the red and blue peaks for all eight capillaries are exactly superimposed and start at the galvanometer reading 50 and end at 210.

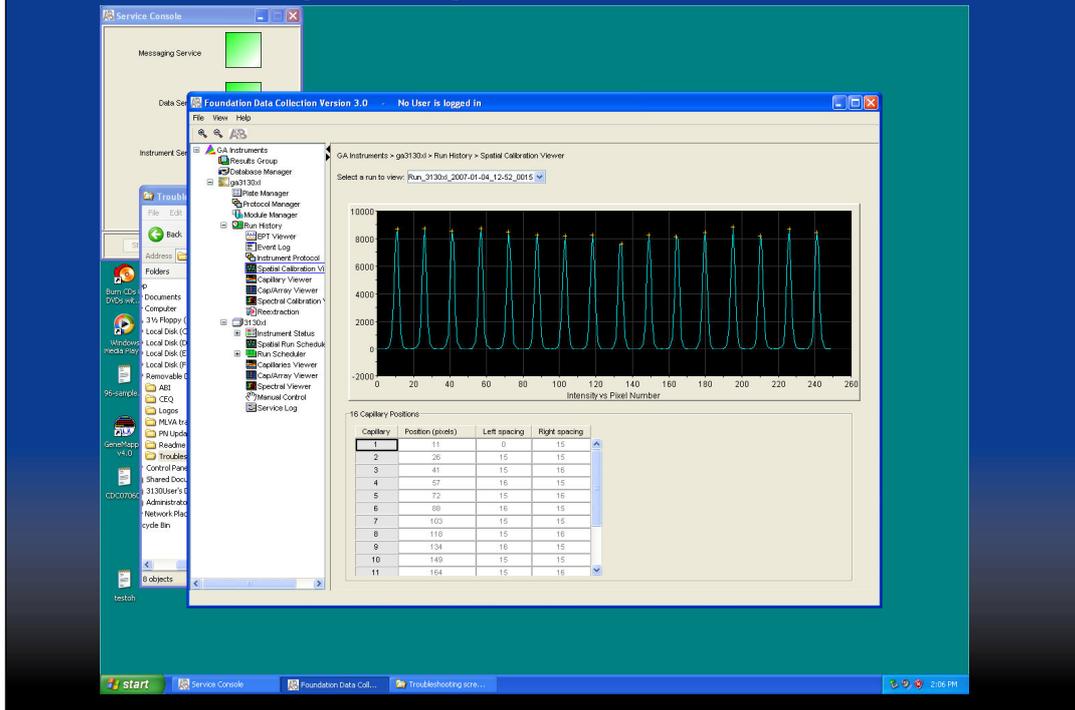
Acceptable spatial calibration - ABI

On the Applied Biosystems Genetic Analyzer, a suboptimal spatial calibration can cause an increased fragment analysis failure rate. In an acceptable spatial calibration, the peaks for each 16 capillaries are sharp, spaced equally and of approximate equal height.
